KSC Ice/Frost/Debris Assessment For Space Shuttle Mission STS-29R

Charles G. Stevenson
NASA/Kennedy Space Center

KSC ICE/FROST/DEBRIS ASSESSMENT
FOR
SPACE SHUTTLE MISSION
STS-29R
MARCH 13, 1989

Approved:
April 30, 1989

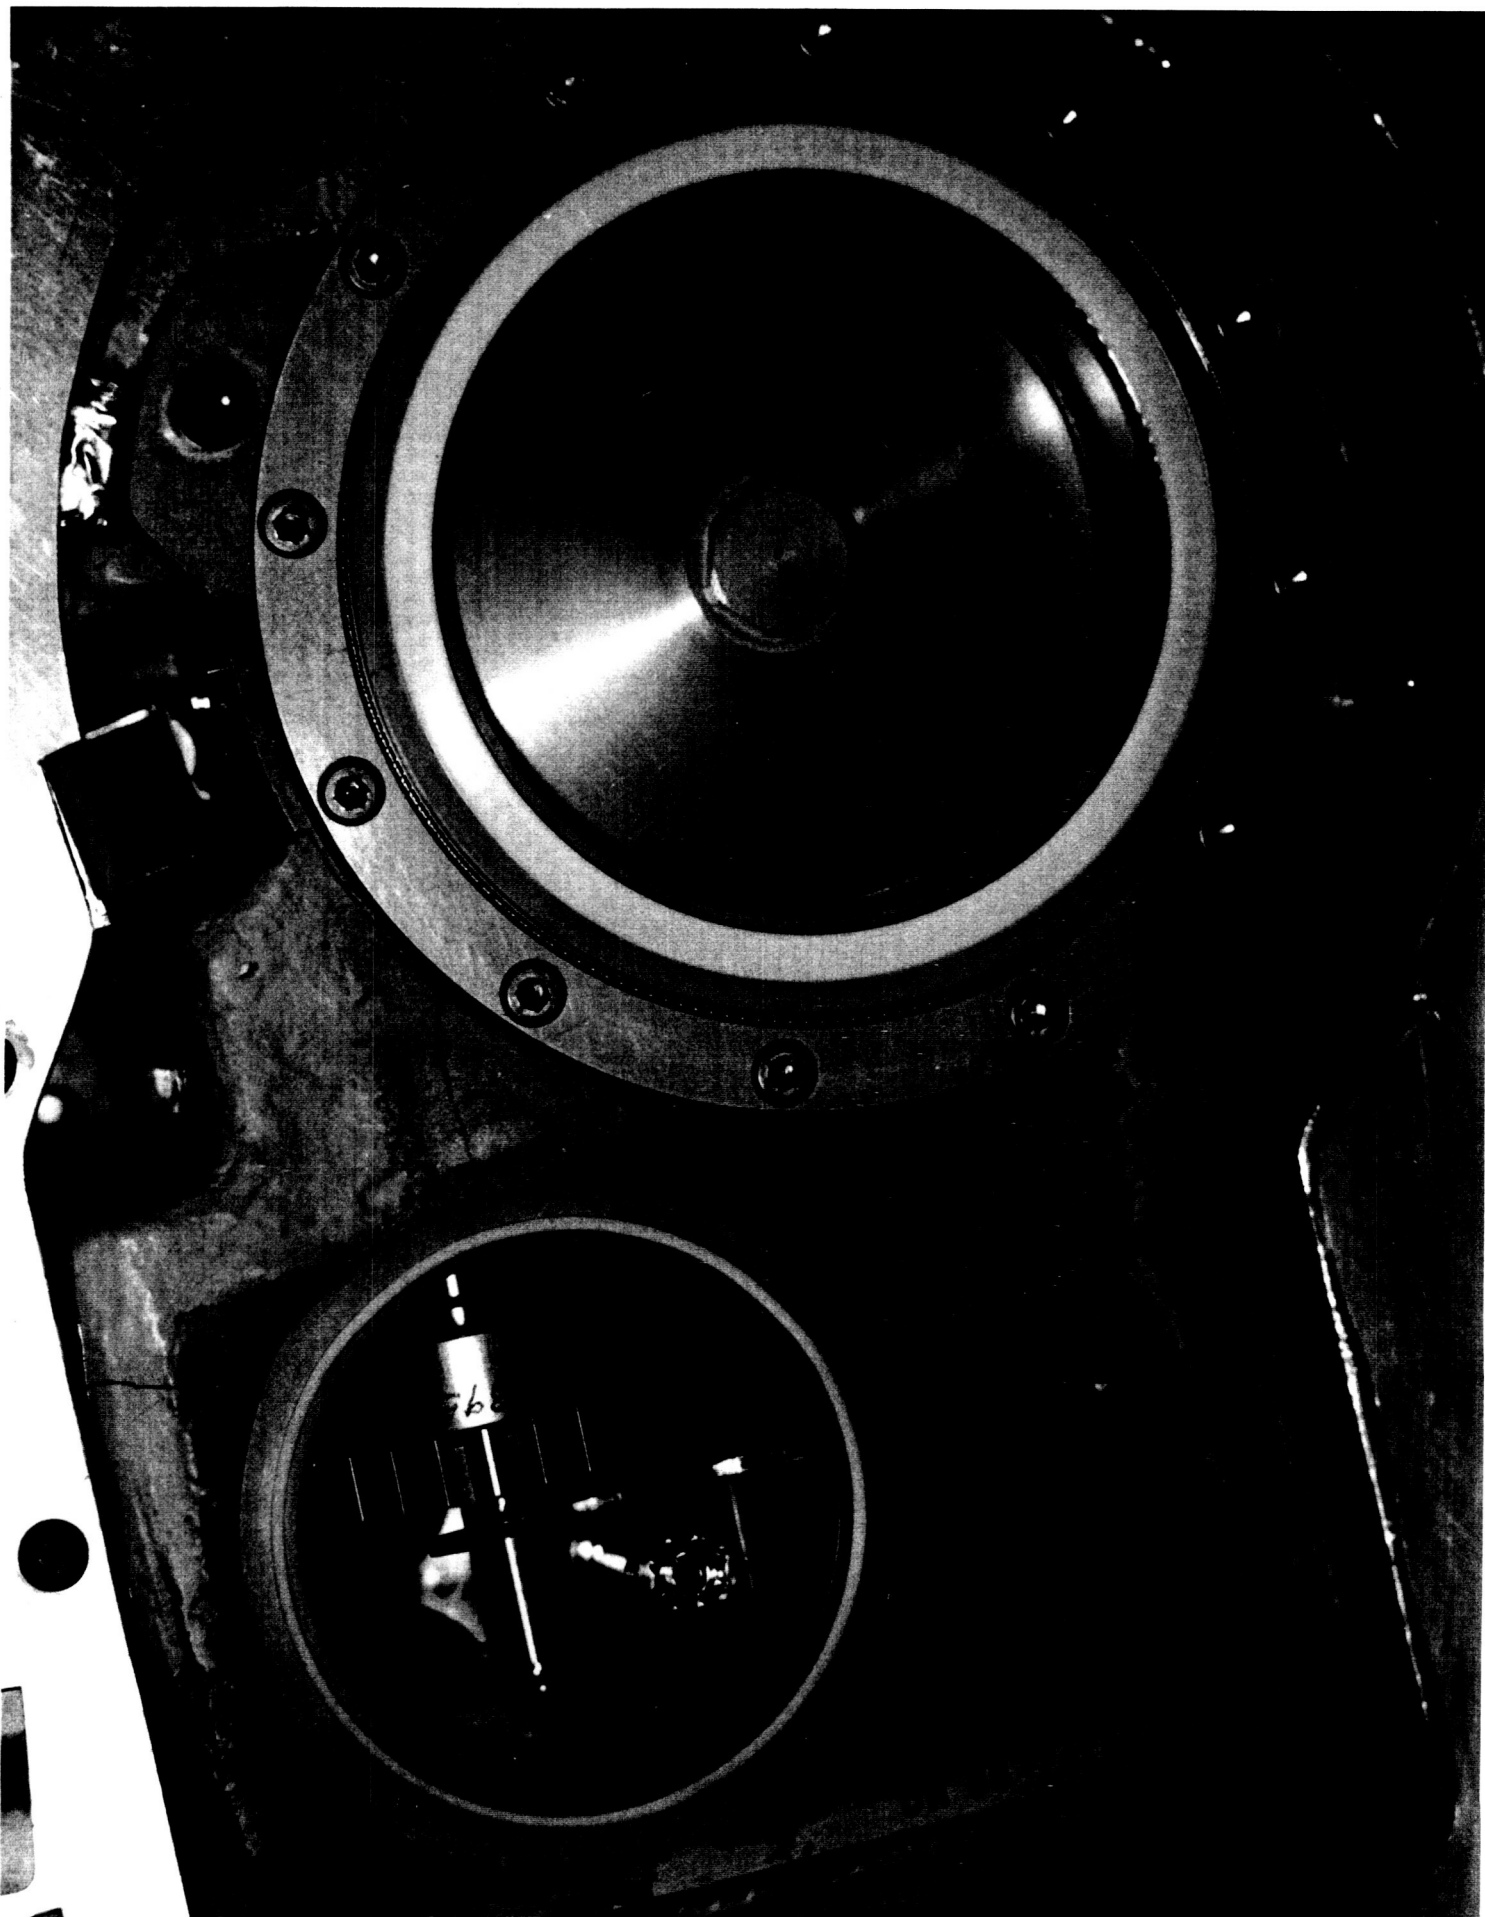
BOTH UMBILICALS EXHIBITED EXCESSIVE FOAM IN THE FLOW
LEAK CHECK PORT CLOSEOUTS
